# **Final Phase Runway Visual Range (RVR) /Automated Surface Observing System (ASOS) Interface Operational Test and Evaluation (OT&E) Report**

September 1998

DOT/FAA/CT-TN98/18

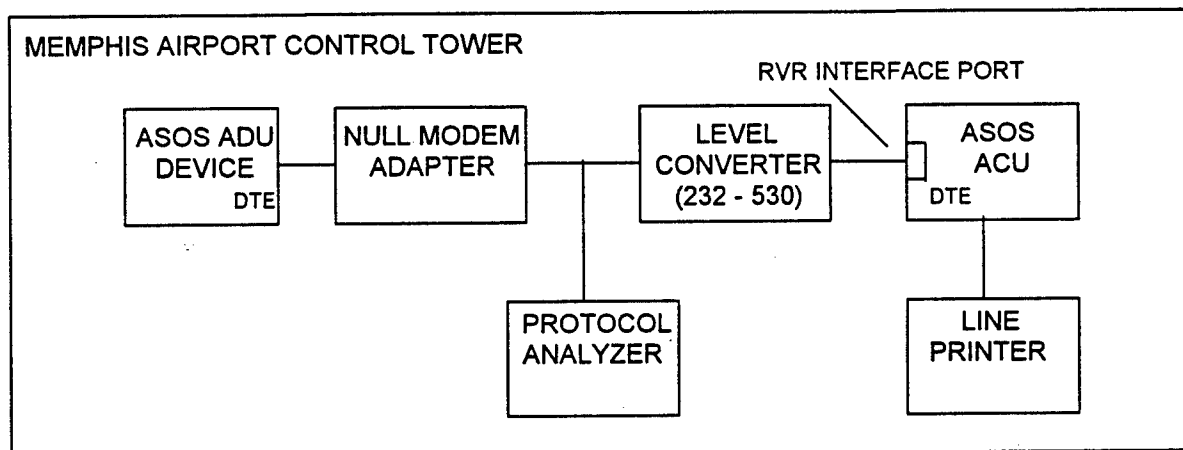
FIGURE 4.5.1.2-1. SIMULATED RVR TO ASOS TEST SETUP

The ASOS ADU generator was connected to ASOS as shown in figure 4.5.1.2-1. The ASOS was initialized with its operational software during test setup.
